STAR 016
V1 – March 2013

Wet runway – hydroplaning

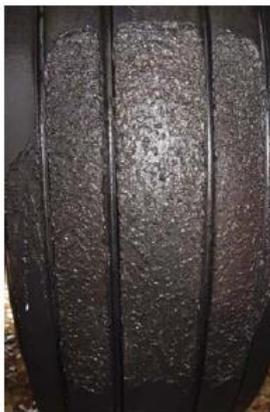
Eyewitnesses stated that the aircraft touched down about 1000 m after the threshold, this was later refined from FDR data to 849 m. All four tyres showed traces of rubber reversion hydroplaning (Figure 1), and had left about 400 m long bright traces on the runway which were definitely caused by rubber reversion hydroplaning (runway marks left following rubber reversion hydroplaning look like they might originate from steam blasting (Figure 2). Furthermore, melted rubber was found on the runway (Figure 3).

Above: figure 1 - marks of rubber reversion hydroplaning on the tyre

Reverted rubber hydroplaning is similar to viscous hydroplaning in that it occurs with a thin film of water and a smooth runway surface. It often follows dynamic or viscous hydroplaning where the wheels are locked. The locked wheel creates enough heat to vaporise the underlying water film thus forming a cushion of steam that eliminates tyre to surface contact, and begins to revert the rubber, on a portion of the tyre, back to its uncured state. Once started, reverted rubber hydroplaning will persist down to very low speeds – virtually until the aircraft comes to a stop. During the skid there is no steering ability. Indications of reverted rubber hydroplaning are distinctive white marks on the runway, and a patch of reverted rubber similar to the uncured state on the tyre. It is also likely that melted away rubber will be found on the runway.

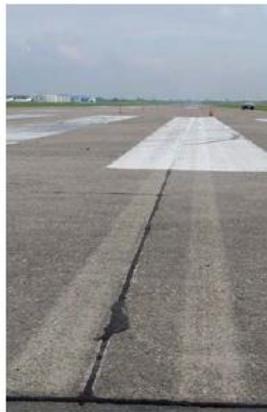
Above: figure - marks of hydroplaning on the runway

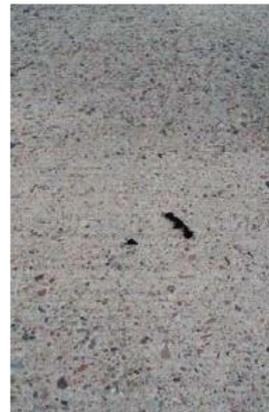
Above: figure 3 - rubber dumped from tyre
